# NBS SPECIAL PUBLICATION 592

## An Investigation of the Miyagi-ken-oki, Japan, Earthquake of June 12, 1978

On June 12, 1978, a destructive earthquake with Richter magnitude of 7.4 occurred off the east coast of Miyagi Prefecture, Japan. Preliminary estimates by the National Land Agency of Japan indicated that the earthquake caused an equivalent of \$800 million in total damage. There is a cooperative agreement between the governments of the United States and Japan termed the U.S.-Japan Program in Natural Resources (UJNR). Following the earthquake, it was arranged through UJNR that teams of U.S. structural engineers and geologists would visit Miyagi Prefecture and inspect the damage caused by the earthquake. This report assembles the information and collective experiences of the investigation team so as to describe the earthquake and document its effects. Field investigations conducted by geologists and structural engineers are described in detail and some of the implications for seismic resistant design and construction of structures in the United States are also discussed.

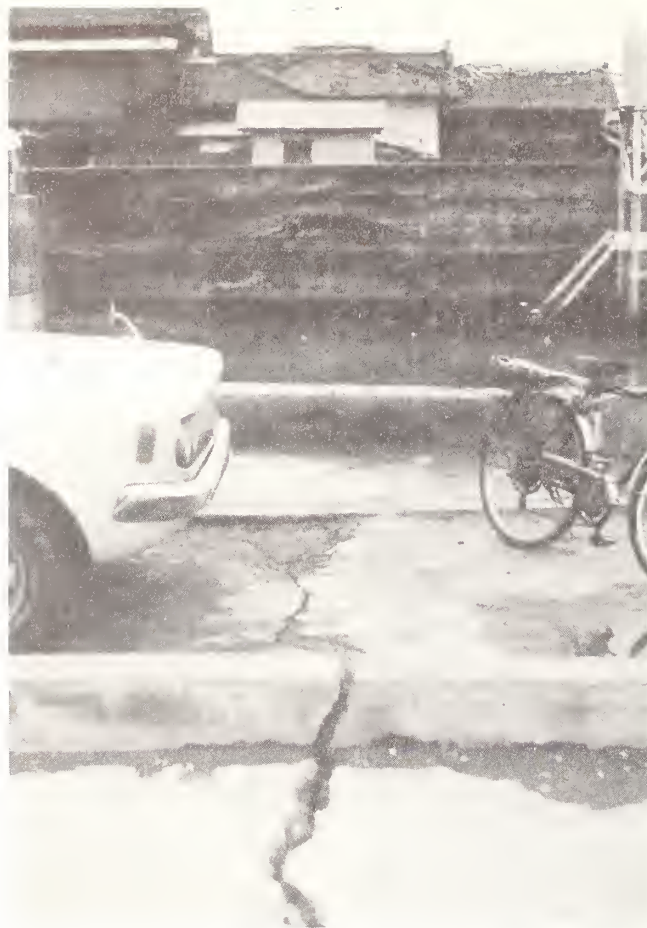
Figure 8.9 Site 2, Natori River--Retaining wall moved laterally and dike crest settled (From Tohoku Regional Construction Bureau, MOC, unpublished data)

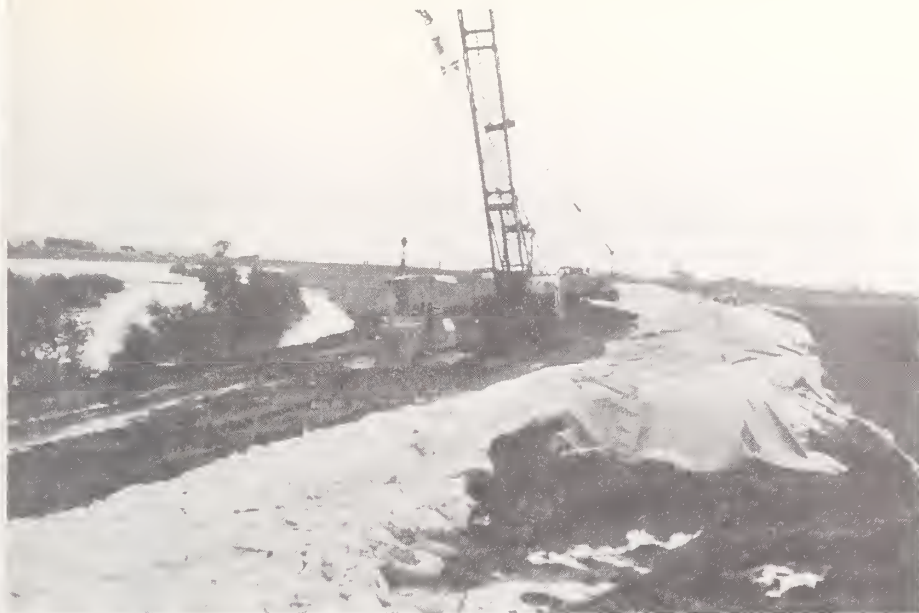
Figure 8.10 Site 3, Yoshida River. View east (downstream) along section of dike where repairs are underway. Dike crest settled as much as 1 m over a length of 5 km. Sand bags have been placed as part of repair process.

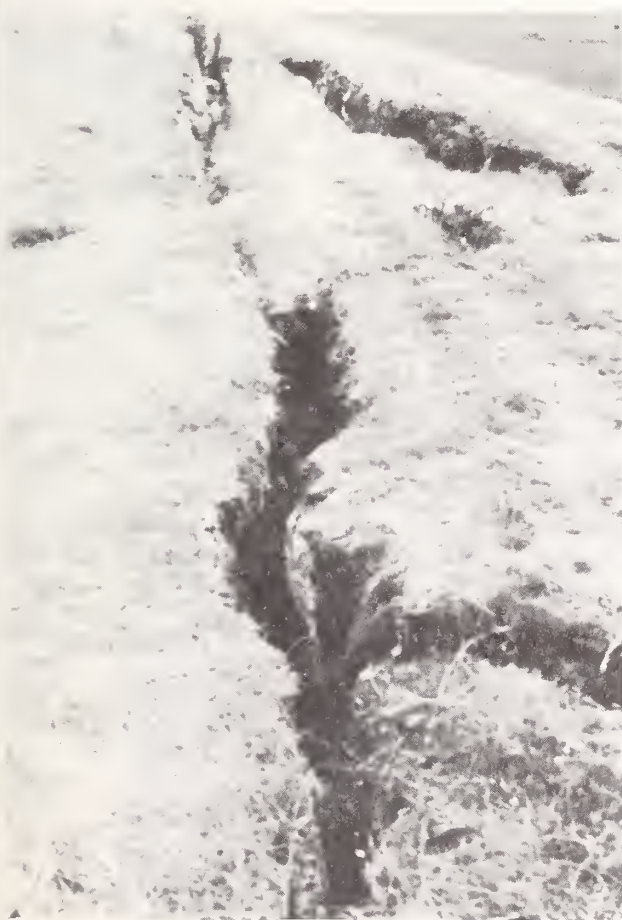
Figure 8.11 Site 3, Yoshida River. Cracks in dike caused by slumping and lateral spreading. Cracks are 10-30 cm wide. View is west. (Photo courtesy K. Kawashima, PWRI)

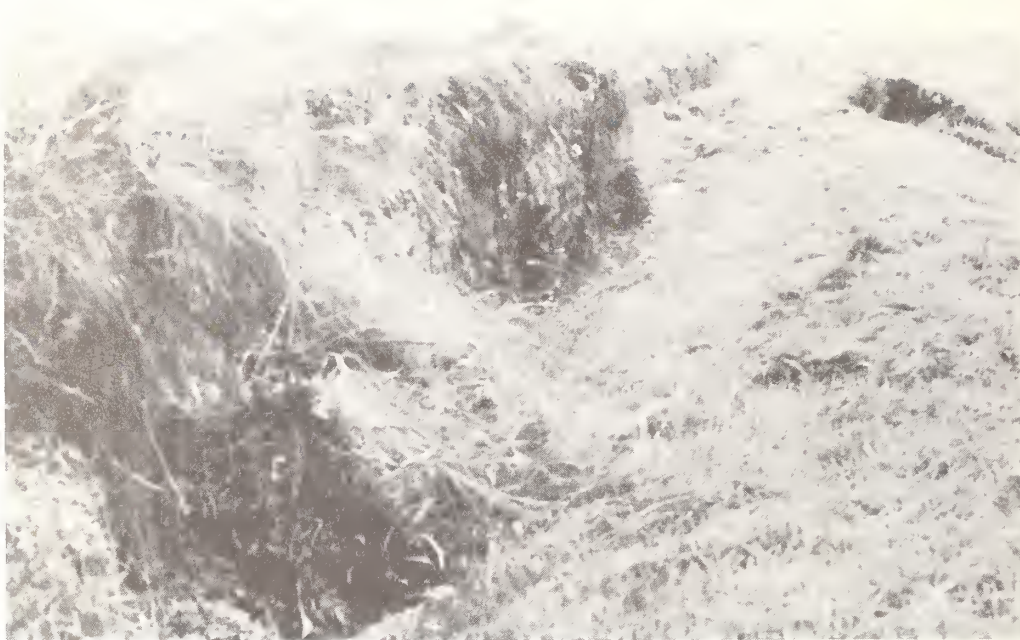
Figure 8.12 Site 3, Yoshida River. Scarps in dike caused by slumping. Note man in background for scale. (Photo courtesy K. Kawashima, PWRI)

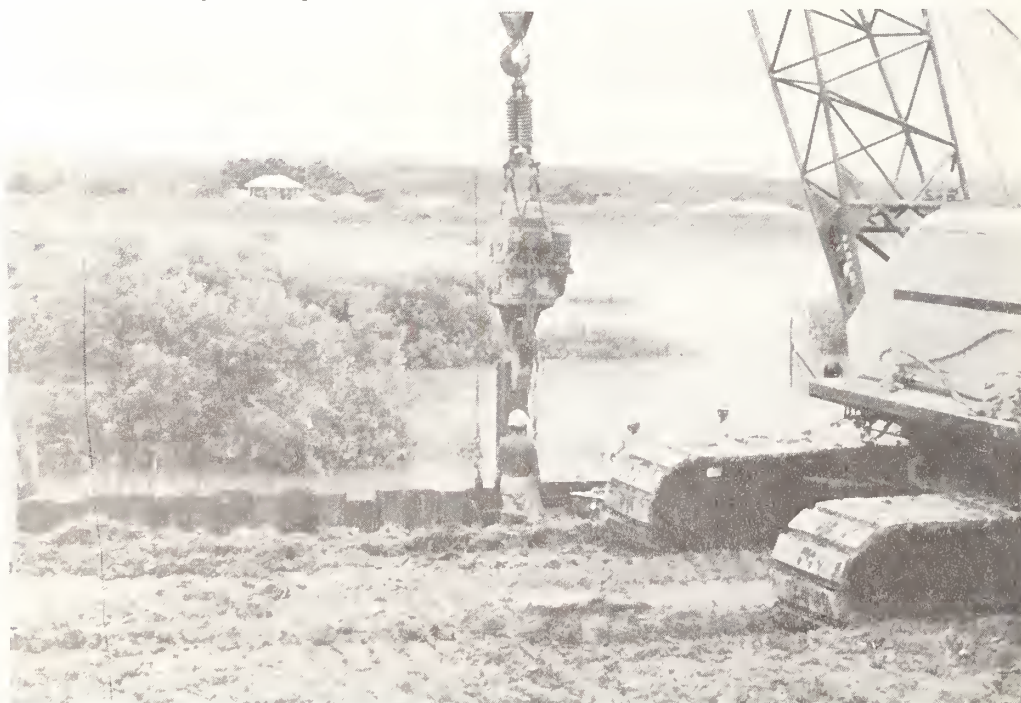
Figure 8.13 Site 3, Yoshida River. Steel sheet piles being placed by vibratory driver as part of repair process. Purpose of sheet piles is to reduce seepage under part of dike weakened by earthquake.

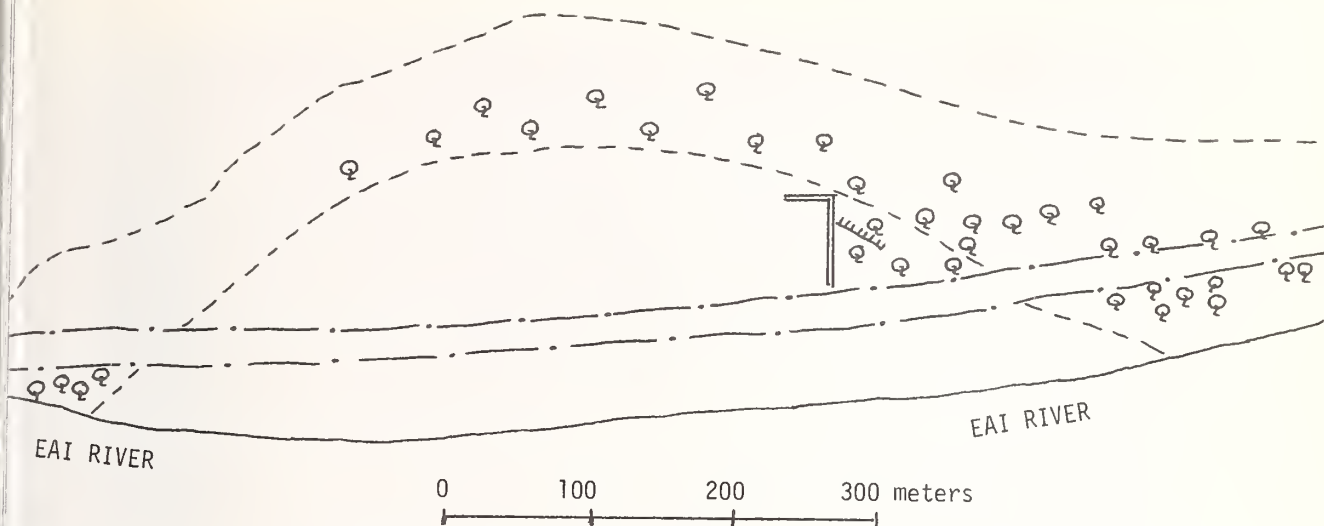
Sand boils were common in an old river channel at Site 4, on the right bank of the Eai River (Figure 8.14). A concrete block fence near this channel was cracked by lateral spreading toward the old channel bank (Figure 8.15). Damage to the dike on this side of the river was minor. Across the river from Site 4, cracks up to 80 cm deep and 10 cm wide occurred in the dike. On both sides of the river, the foundation material contains much soft clay. Some layers of silt and sand may also be present. It was reported that the dikes were built relatively slowly, and significant settlement took place during construction (K. Kawashima, PWRI, oral communication).

Figure 8.14 Site 4, Eai River--Most sand boils occurred in old river channel. Minor cracking of dike apparently occurred where dike crosses old channel, but cracks were repaired prior to visit. (After Tohoku Regional Construction Bureau, MOC, unpublished data)

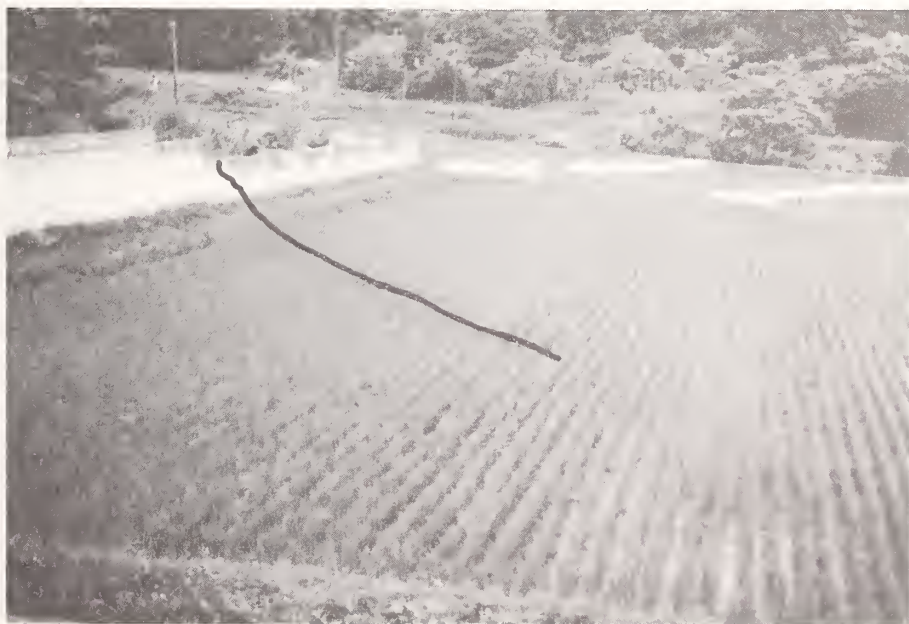
Sand boils occurred in the rice field adjacent to the dike (Figure 8.16), but damage to the dike itself was apparently minor. Subsurface material at Site 5 consists of alternating layers of silty sand and clay to a depth of 15 m. (T. Tazaki, PWRI, oral communication).

Figure 8.16 Site 5, Old Kitakami River - Sand boils in rice field. Plants are several centimeters tall. Damage to the dike at this site was minor. (Photo courtesy K. Kawashima, PWRI)

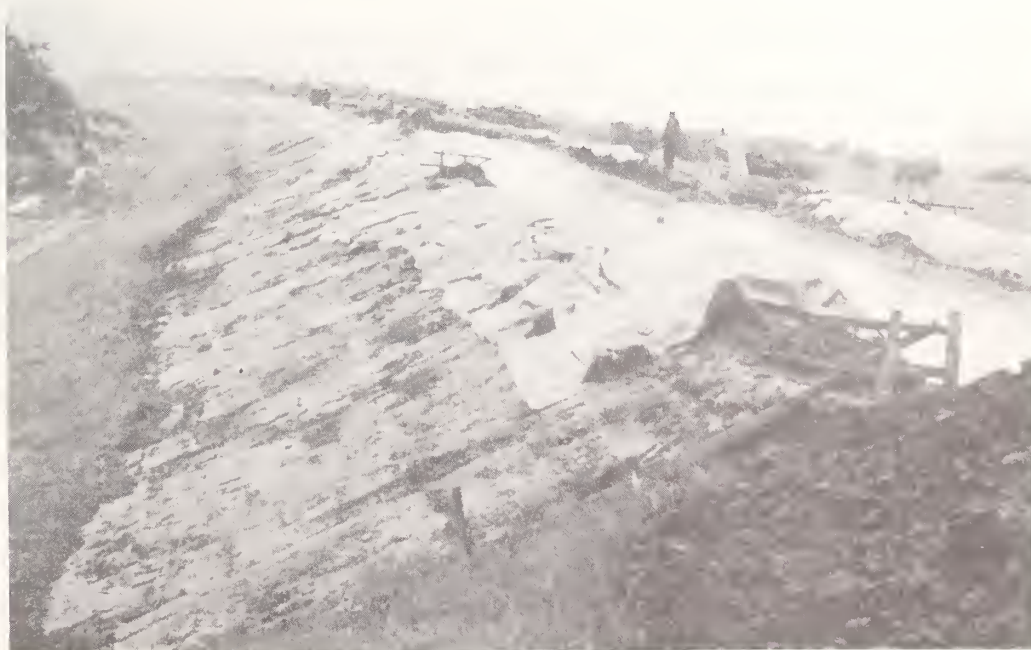
Figure 8.18 Site 6, New Kitakami River. Cracking of dike crest and roadway due to liquefaction-induced slumping. (Photo courtesy K. Kawashima, PWRI)

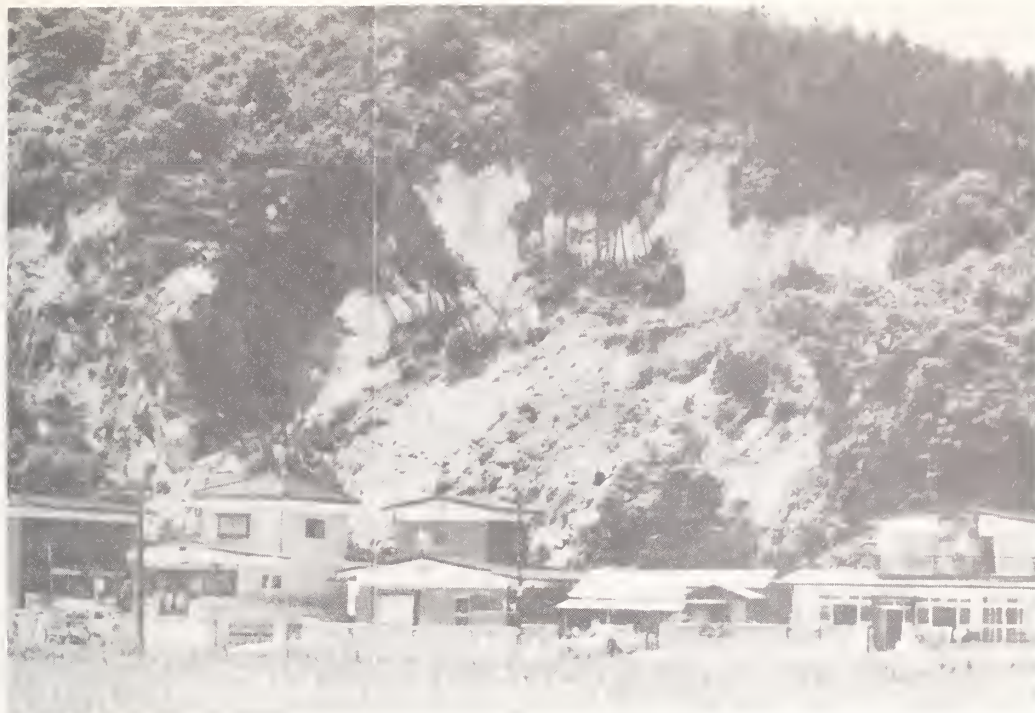
Two of the largest rock falls from the earthquake occurred near Takayamashita in Matsushima town west of the Takagi River on steep (greater than 45°) natural slopes. The larger of these rock falls (Figure 9.2) occurred in a deeply weather and closely jointed Miocene tuff breccia (Geologic Map of Miyagi Prefecture) exposed in a 45-m scarp. The slope affected is approximately 110 m wide, and the volume of debris is about 6,000 m<sup>3</sup>. The rock fall damaged four houses built next to the slope. A close view of some of the damage to the house second from the left in Figure 9.2 is shown in Figure 9.3.

Figure 9.2 Rock fall on steep slopes of Miocene pumiceous tuff breccia near Takayamasuita. This rock fall damaged four houses close to the base of the slope. (Photograph courtesy of Y. Tsuruya, Slope Protection Division, Ministry of Construction).

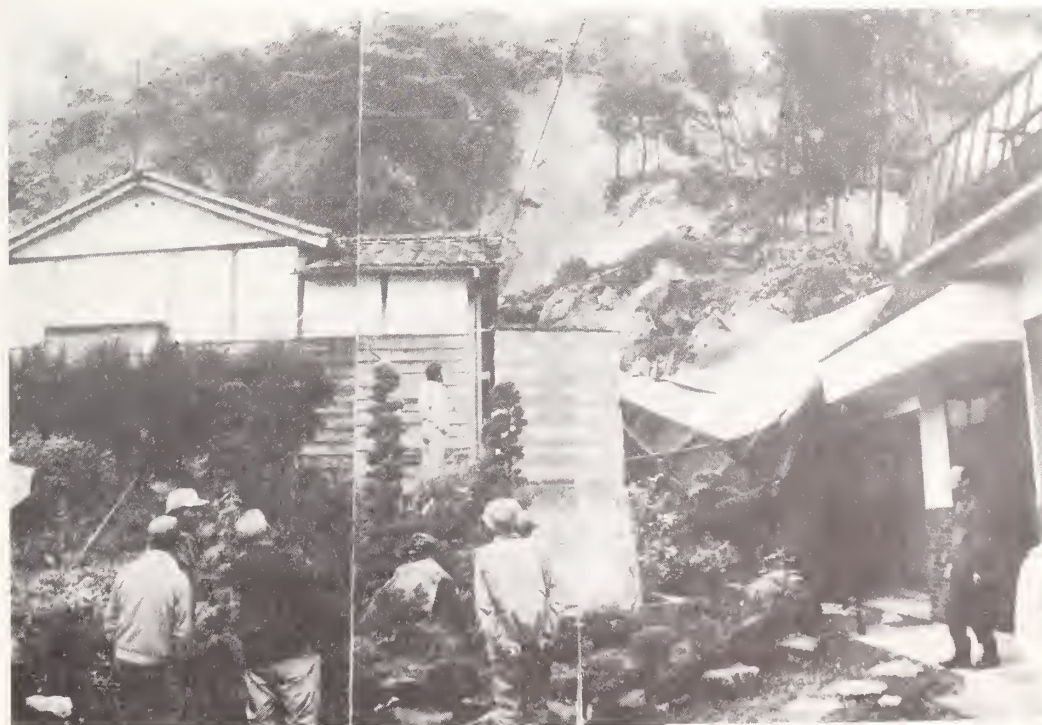
Figure 9.3 Closeup of rock fall damage to houses shown in left portion of figure 9.2. (Photograph courtesy of Y. Tsuruya)

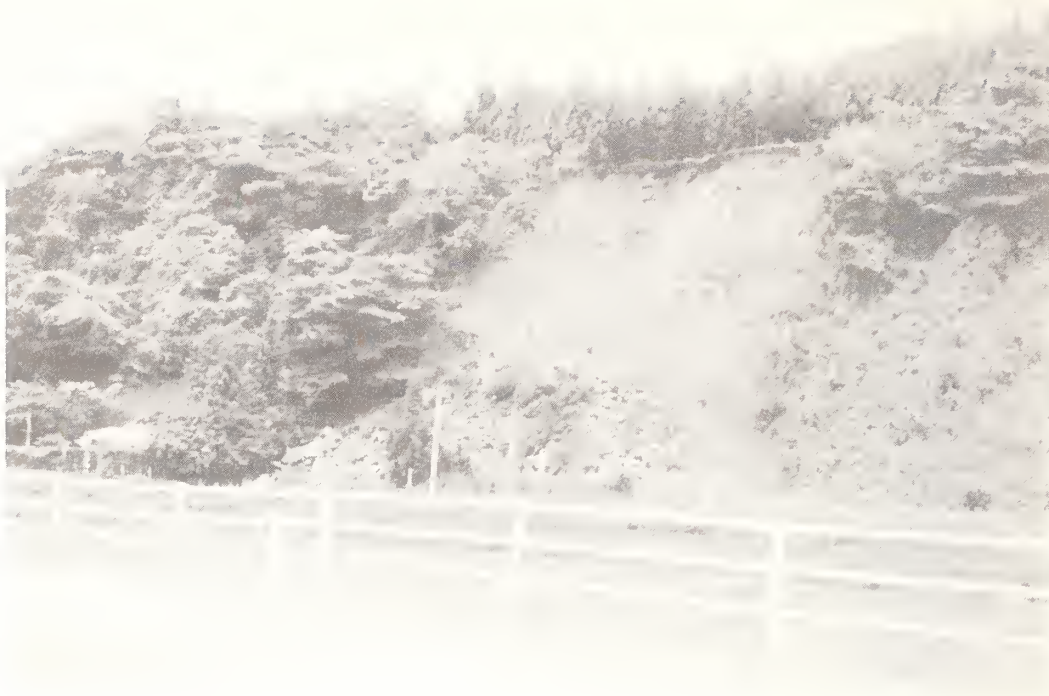
About 0.5 km to the north, a smaller rock fall occurred on a steep slope in dark brown volcanic rocks (Miocene tuffs (?)). The scarp is about 20 m high and about 50 m wide (Figure 9.4). The debris is blocky and includes boulders up to 2 m in diameter. The scarp reveals extensively fractured bedrock. The fractured surfaces probably provided planes of weakness along which the rock failed.

Figure 9.4 Rock fall on steep slopes in volcaniclastic sediments.

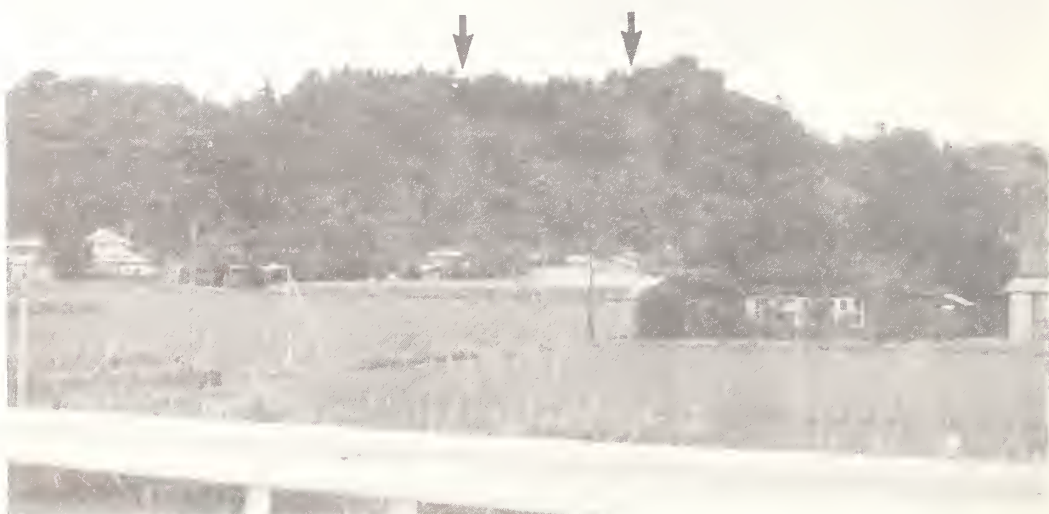
Three rock falls occurred on steep east-facing bluffs flanking a broad flood plain near the mouth of the Naruse River. All three were narrow failures, about 15 m wide, that occurred in dark brown volcanic rock similar to the smaller rock fall at Site No. 1. The slides extended from near the crest of the bluffs to the base, a height of approximately 30 m. Two of the slides are shown in Figure 9.5.

Figure 9.5 Rock falls (arrows) in steep bluffs bordering flood plain near mouth of Naruse River.

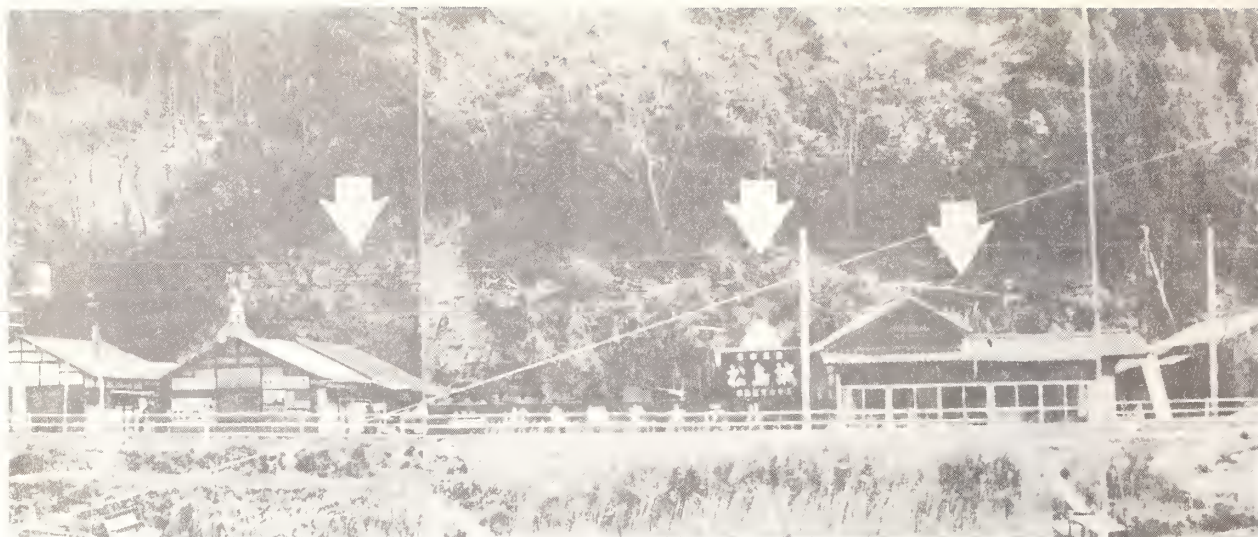
Near Atago in Matsushima, approximately 1.0 km east of the Site No. 1, rock falls from tuff, similar to the tuff forming the larger rock fall at Site No. 1, damaged outbuildings near three houses. About 500 m<sup>3</sup> of debris was shaken from cut slopes 15 m in high beneath which houses and storage buildings were closely juxtaposed (Figure 9.6). Most of the damage was not to the houses proper but to attached storage sheds and outbuildings as shown in Figure 9.7.

Figure 9.6 Panoramic view of houses damaged by rock fall from adjacent cut slope in tuff\*. Rightmost arrow points to area shown in figure 9.7. (Photograph courtesy of Y. Tsuruya).

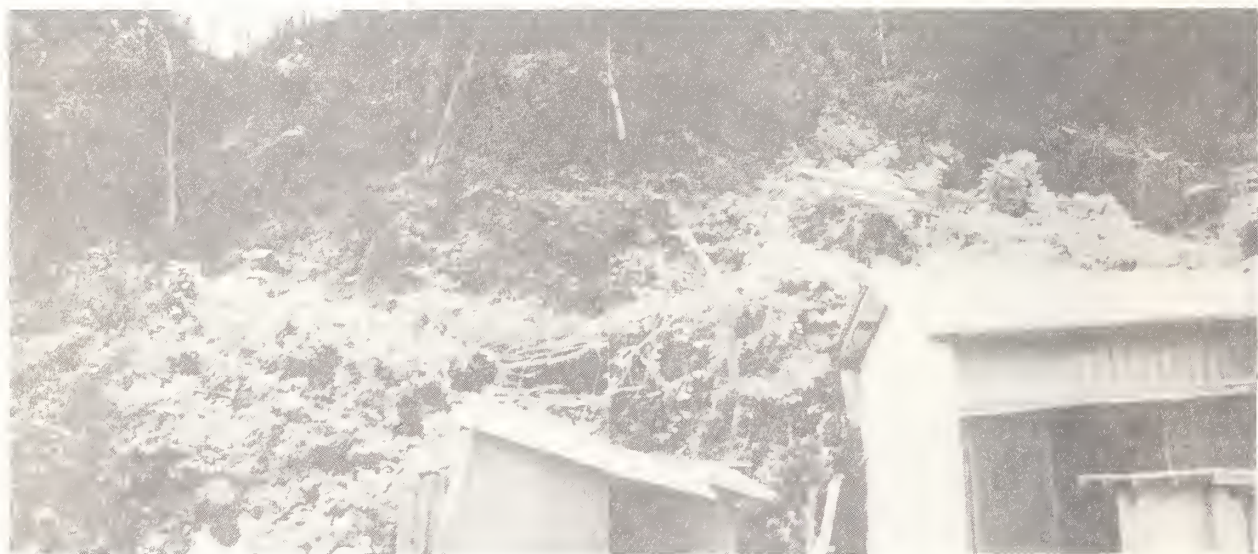
Figure 9.7 Closeup of rock fall and damage to buildings shown in right-hand portion of figure 9.6. (Photograph courtesy of Y. Tsuruya)

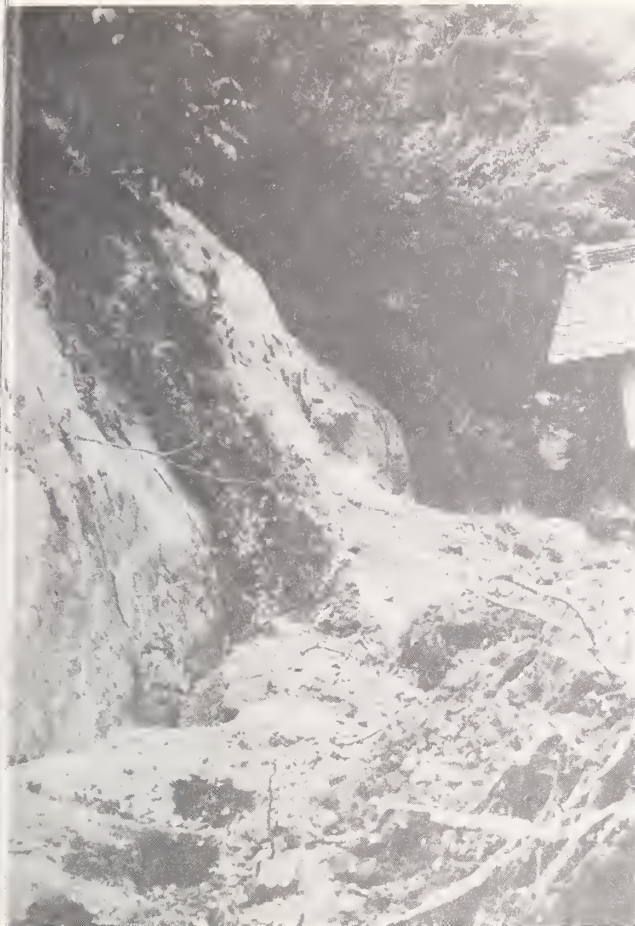
Approximately 3 km east of Atago in Mototetaru, Matsushima, small rock falls occurred in tuff-breccia deposits, damaging several storage buildings adjacent to houses. Failures occurred along a section of cut slope about 100 m in long and produced about 200 m<sup>3</sup> of debris. The slope is 10-13 m high and is inclined at about 60°. One rock fall and a scarp exposing tuff breccia is shown in Figure 9.8.

Figure 9.8 Rock fall from steep slope in pumiceous tuff breccia near Mototgtaru. Failure was about  $200 \text{ m}^3$  in volume. (Photograph courtesy of Y. Tsuruya)

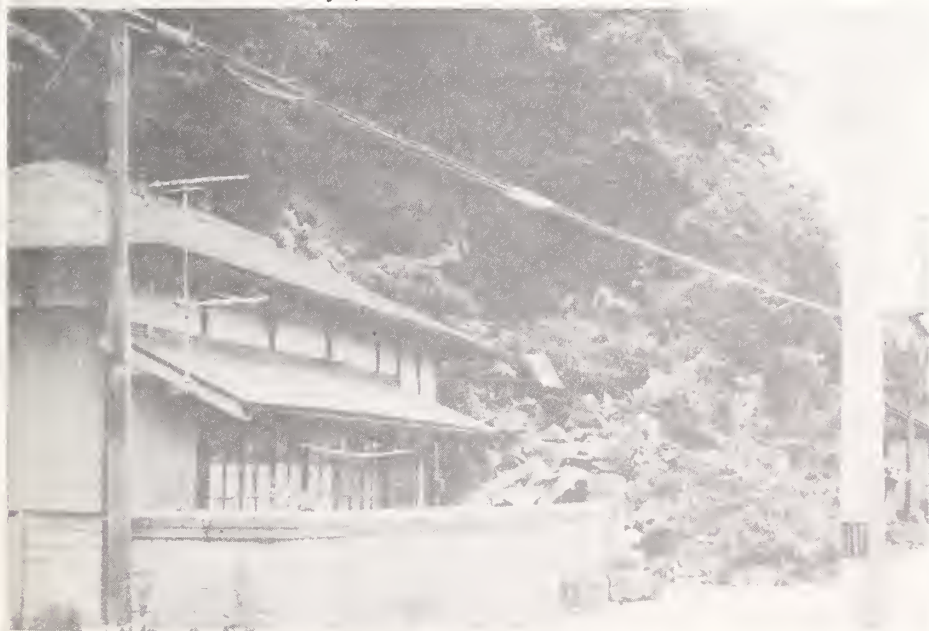
At Kakinoura in Matsushima, about 100 m<sup>3</sup> of blocky debris was produced by a seismic-induced rock fall in tuff that damaged a concrete wall adjacent to a house. This rock fall occurred on the nose of a narrow ridge of about 35 m local relief. The slope failed along pre-existing fractures or joints and produced blocks of debris as long as 1.0 m. The size of the blocks reflects the fracture spacing of the rock. The rock fall and the house adjacent to the damaged concrete wall are shown in Figure 9.9. Two other small rock falls nearby did minor damage to walls of three other houses.

Figure 9.9 Rock fall in Miocene tuff causing damage to concrete wall adjacent to house. (Photograph courtesy of Y. Tsuruya)

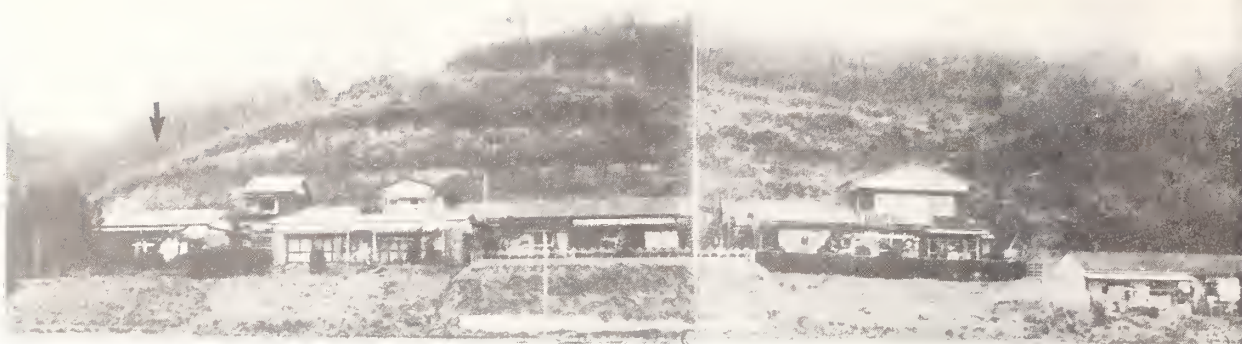
At Kitashionai, Murata, 25 km southwest of Sendai, another steep slope in tuff failed, generating a small rock fall damaging one house. Figure 9.10 shows several houses near the nearly vertical cut slope about 15 m high. One of these houses suffered damage to a retaining fence and part of the roof. A closeup of the rock fall and roof damage is shown in Figure 9.11.

Figure 9.10 Panorama of cut slope near Kitashiona in Miocene tuff which produced rock falls during earthquake damaging nearby houses. Arrow points to damaged house shown in closer view in figure 9.11. (Photograph courtesy of Y. Tsuruya)

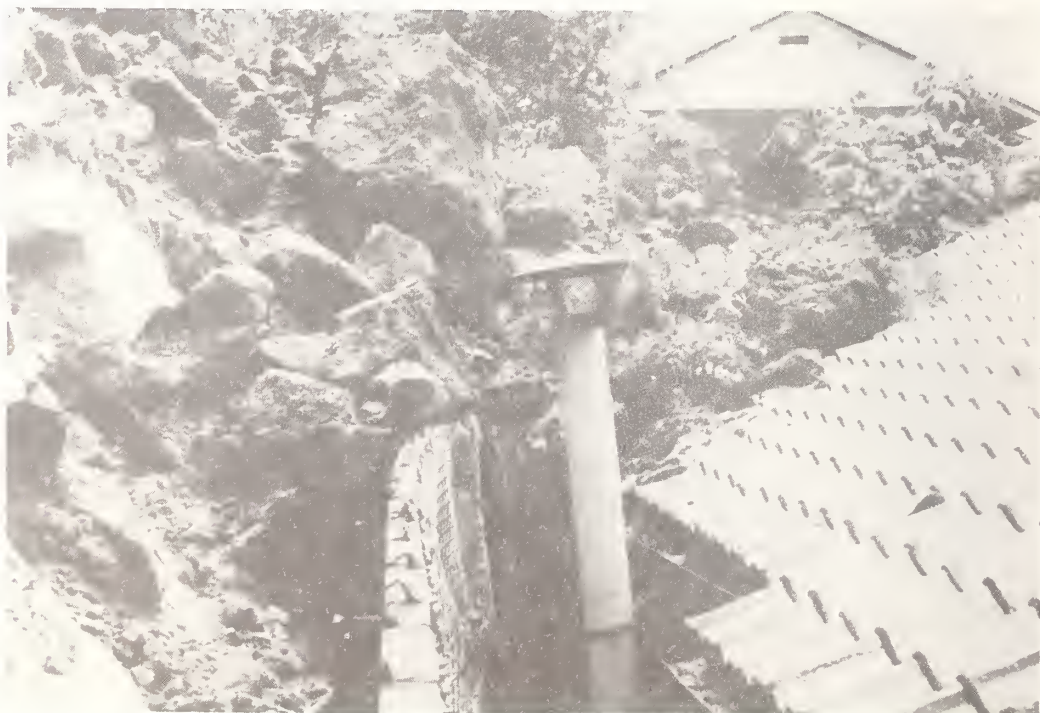
Figure 9.11 Rock fall damage to retaining wall and roof of house in left-hand portion (arrow) of figure 9.10. (Photograph courtesy of Y. Tsuruya)

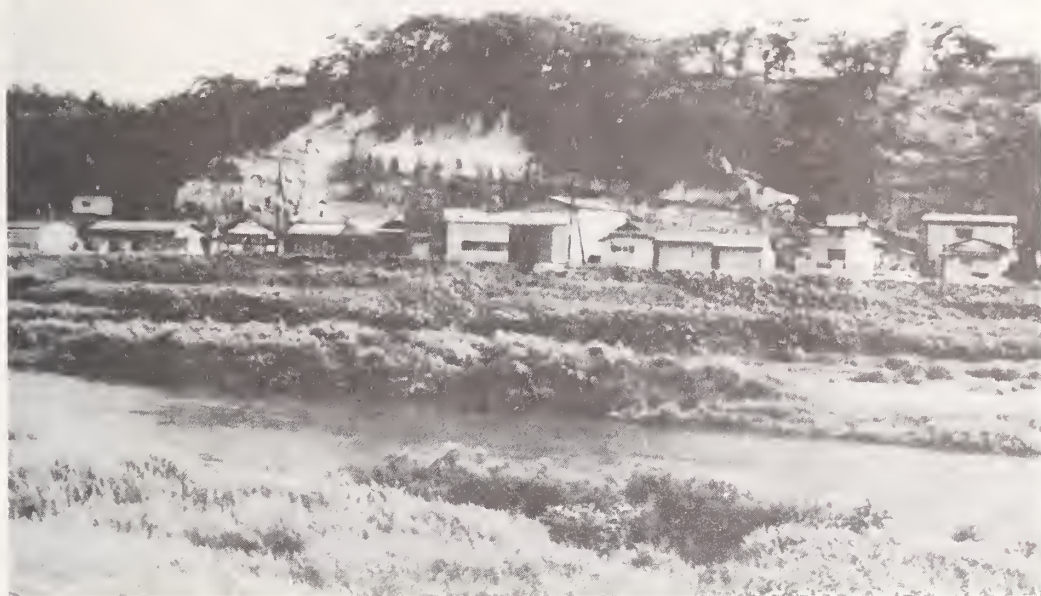
Figure 9.12 Steep slope near Hebinumayama in heavily fractured tuff which underwent failure as rock falls damaging portions of houses in front of the slope.

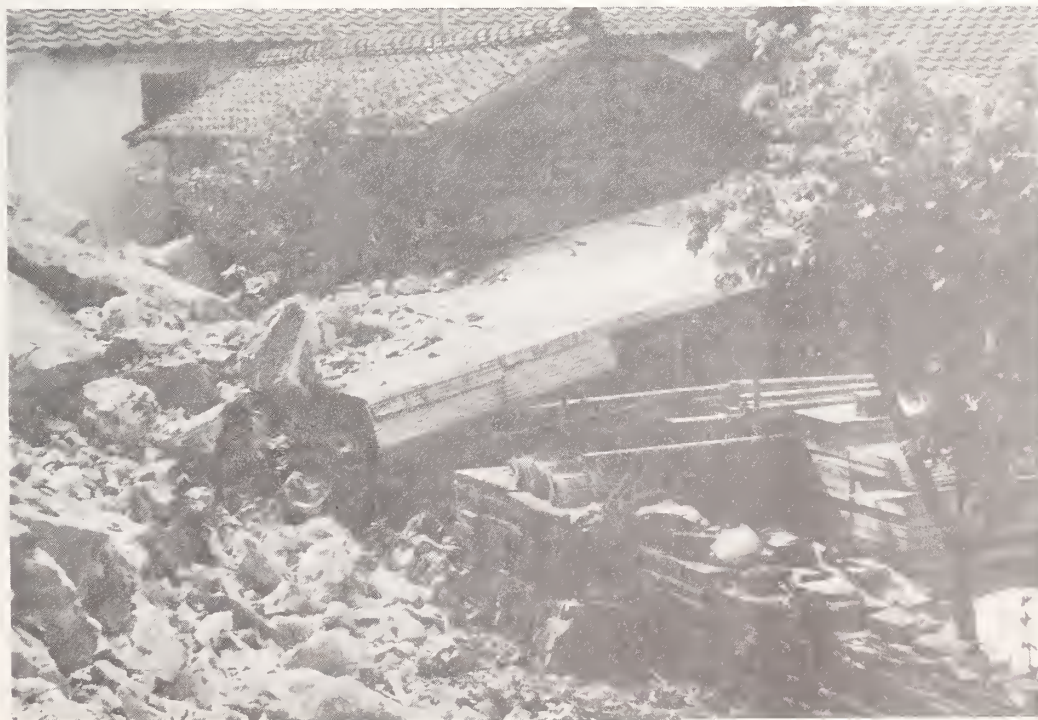
Figure 9.13 Rock fall from slope shown in figure 9.12 impinging on storage shed next to slope.

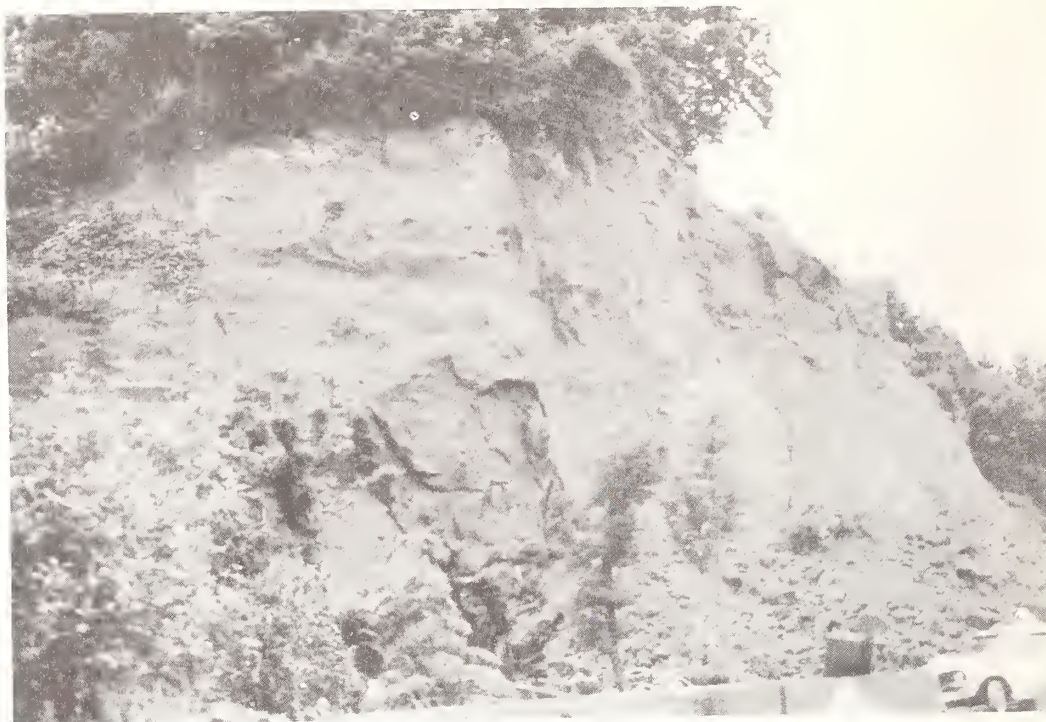
A typical roadcut failure (Figure 9.14) was derived from weakly cemented sandstone along a valley west of the Naruse River. The rock fall is less than 1 m thick, and slope height is about 10 m.

Figure 9.14 Rock fall from roadcut in weakly cemented sandstone.

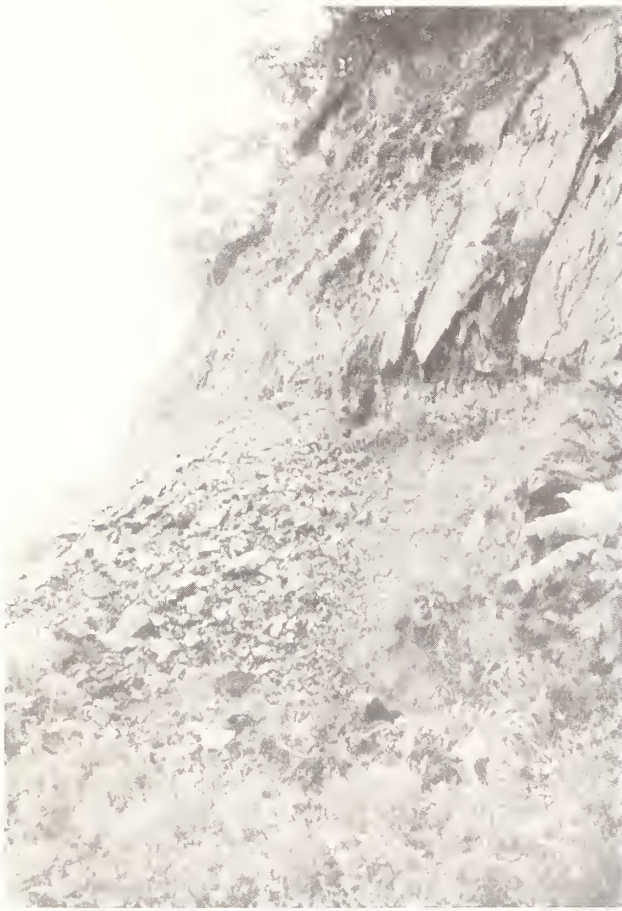
A rock fall in Triassic slate and fine-grained quartzite occurred on a steep roadcut slope on the north side of the New Kitakami River. The scarp of the rock fall is inclined at about  $60^\circ$  and is formed by prominent slaty cleavage planes (Figure 9.15). The blocky debris broke into pieces of up to 30 cm in longest dimension. Almost all of the debris consisted of blocks that had separated along pre-existing fractures.

Figure 9.15 Rock fall in roadcut. Note slaty cleavage planes that form the rock fall scarp.

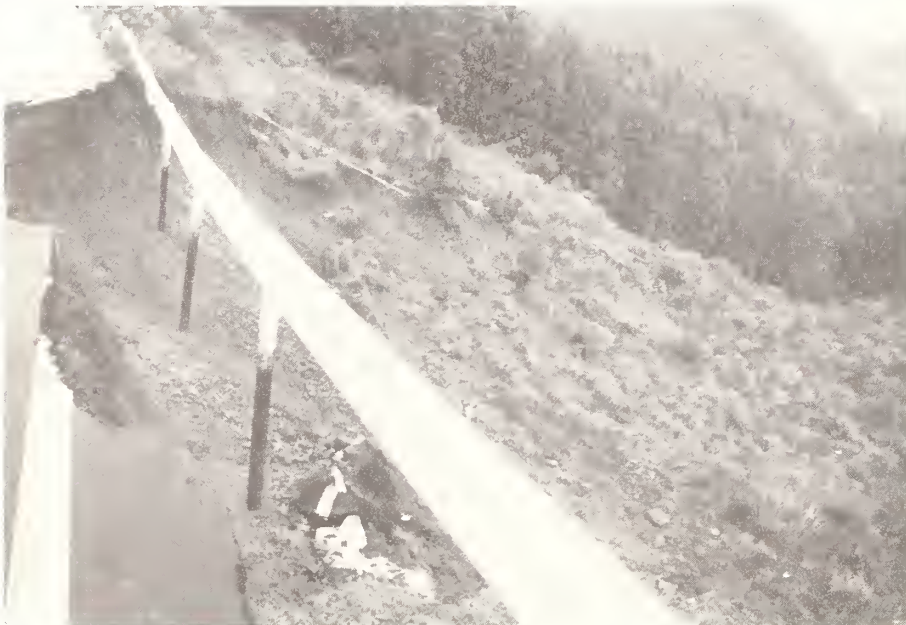
Several artificial fill failures occurred on roads on the Ojika Peninsula; one such failure is shown in Figure 9.16. The fill material slumped away from beneath the road surface and formed a scarp cutting about 2 m into the highway. The fill appeared to be either uncompacted or poorly compacted sandy clay derived from adjacent bedrock and soil. This failure occurred at a site where rainfall-induced slumping had occurred repeatedly before the earthquake (T. Tazaki, 1978, oral communication). At the time of the visit, plastic sheets had been spread over the extensively cracked pavement to prevent or minimize rainfall infiltration into the scarp area. During observation, heavy rainfall was mobilizing the debris into small mudflows.

Figure 9.16 Slump in artificial fill along a highway on the Ajika Peninsula.

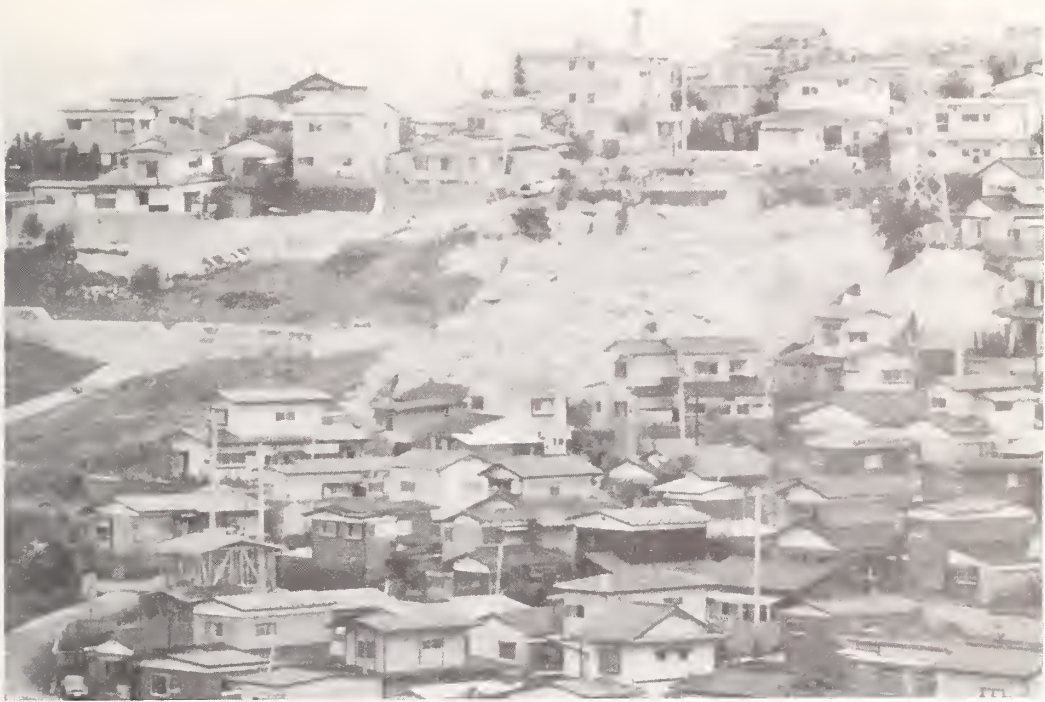
Many slope failures in artificial fill took place within the city limits of Sendai. These failures were mainly slumps. In the neighborhood of Midorigaoka, a large rotational slump occurred in a fill slope of about  $15^\circ$ , composed of gravelly clay. From the headwall scarp to toe, the slump extends approximately 70 m horizontally and 20 m vertically (Y. Matsuzaki, 1978, unpublished data); it is approximately 30 m wide and about 14 m in maximum thickness, thus the approximate volume is  $30,000 \text{ m}^3$ . Most of the slump was above and to the right of one of the 1400 concrete slope-protection dams (sabo works) in Sendai (Figure 9.17). The slump-mass had been covered with nylon tarps before the photograph was taken to prevent infiltration of rainfall.

Figure 9.17 Rotational slump in artificial fill in Sendai (area covered by tarps) which destroyed one house and is threatening others. To left of slump is concrete slope protection dam (sabo works).

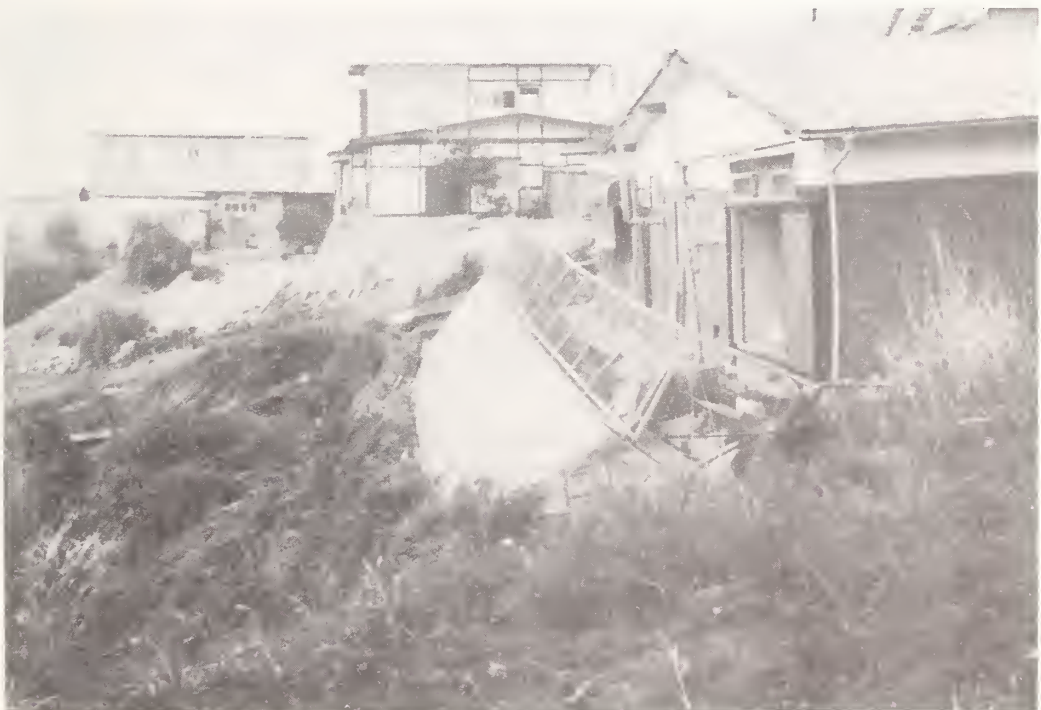
Many houses had been removed from this slope in previous years due to rainfall-induced slumping; as a result, only one house near the headwall scarp was severely damaged by the seismic-induced sliding. Figure 9.18 shows this house, which was being undercut by the multiple scarps at the head of the slump. The fence in the figure shows the rotational component of slump movement.

Figure 9.18 House near head of slump. House was removed due to undercutting by headwall scarp (Photograph courtesy of Y. Tsuruya).
